Site Address: HOLY TRINITY CHURCH, CUCKFIELD, RH17 5JZ

Further to your recent telephone instructions received on 17th July 2019, our surveyor has carried out an inspection for rot, decay and wood boring insect activity to the Lychgates at Holy Trinity Church.

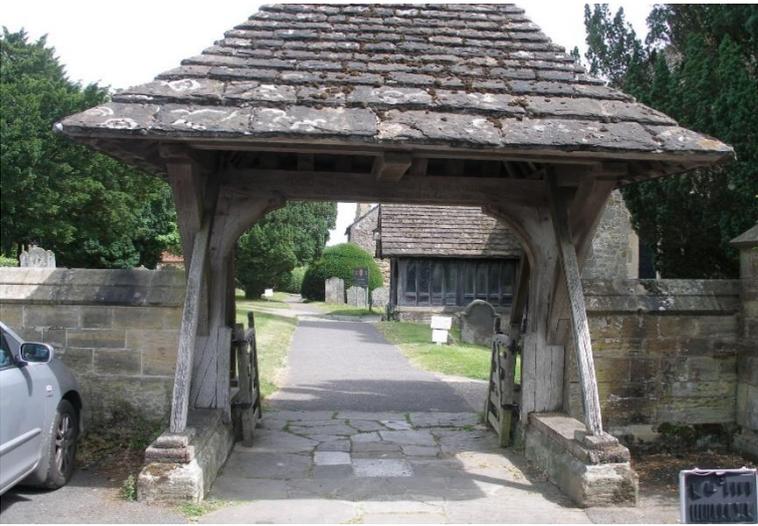
West Gate.

There is a live ongoing infestation of Death Watch Beetle (*xestobium rufovillosum*) in the timbers of both gates. Two of the square supporting piers in the North Gate are particularly heavily infested.

Stage 1 – This should be the treatment and control of the active Death Watch Beetle infestation in both gates as a matter of urgency.

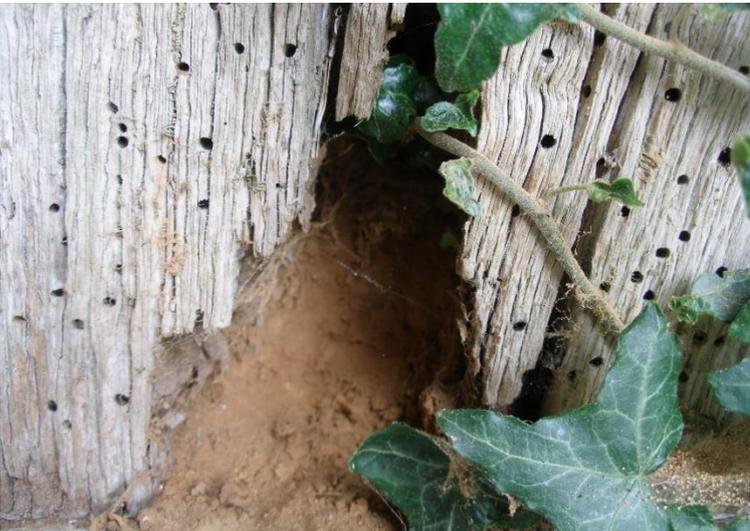
Infestation to a pier in the north gate.

Stage 2 – This should be the cutting out and removal of any structurally weakened timbers before splicing in replacement oak timbers. This will probably be two of the supporting piers in the north gate plus some smaller supporting timbers and probably some of the base timbers in the west gate.

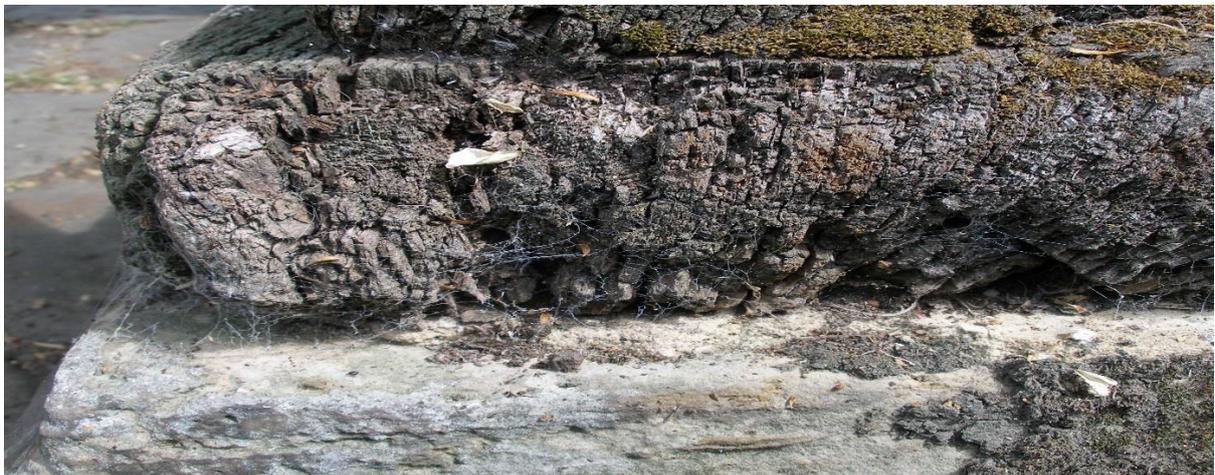
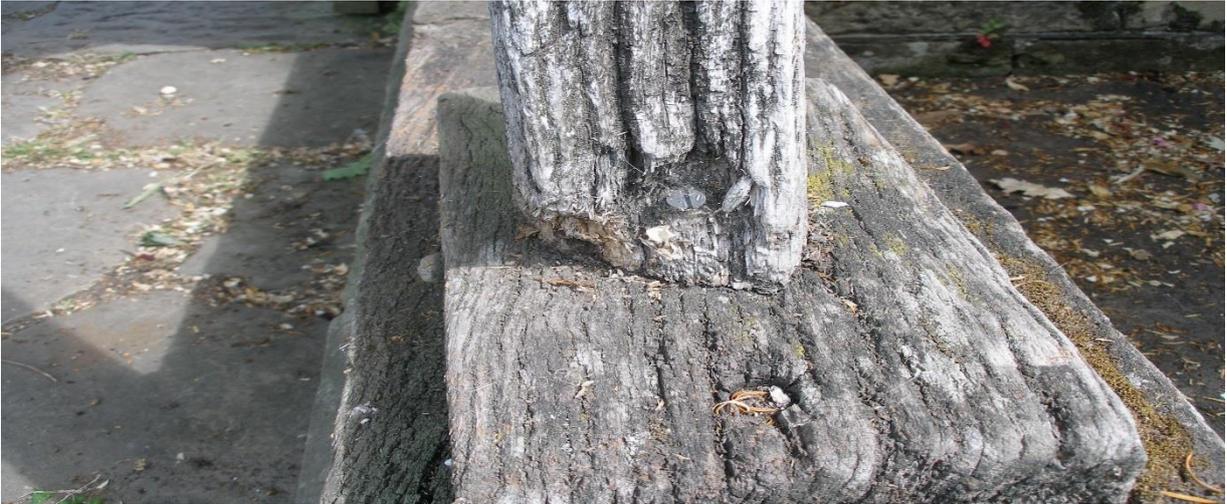
There is noticeable deterioration at the base of both gates, including at least three of the six square piers at the north gate. Neither gate appears to have had any sort of recent renovation apart from the renewal of the small double gates in 2000 at the North end.

Some of the base timbers in the west gate are shown below.

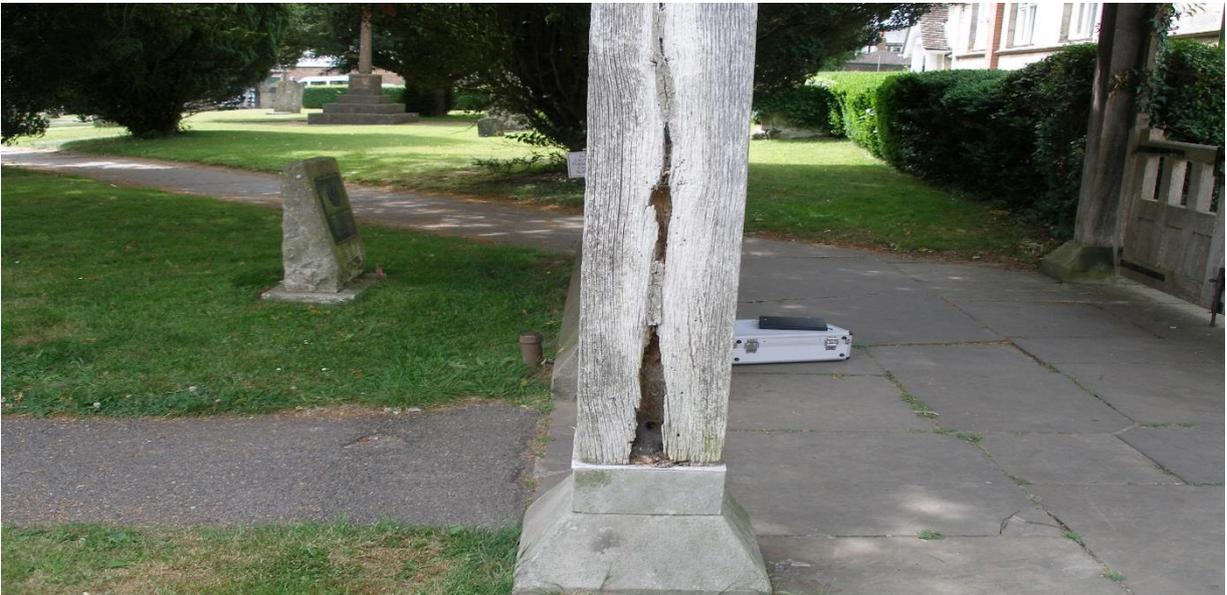
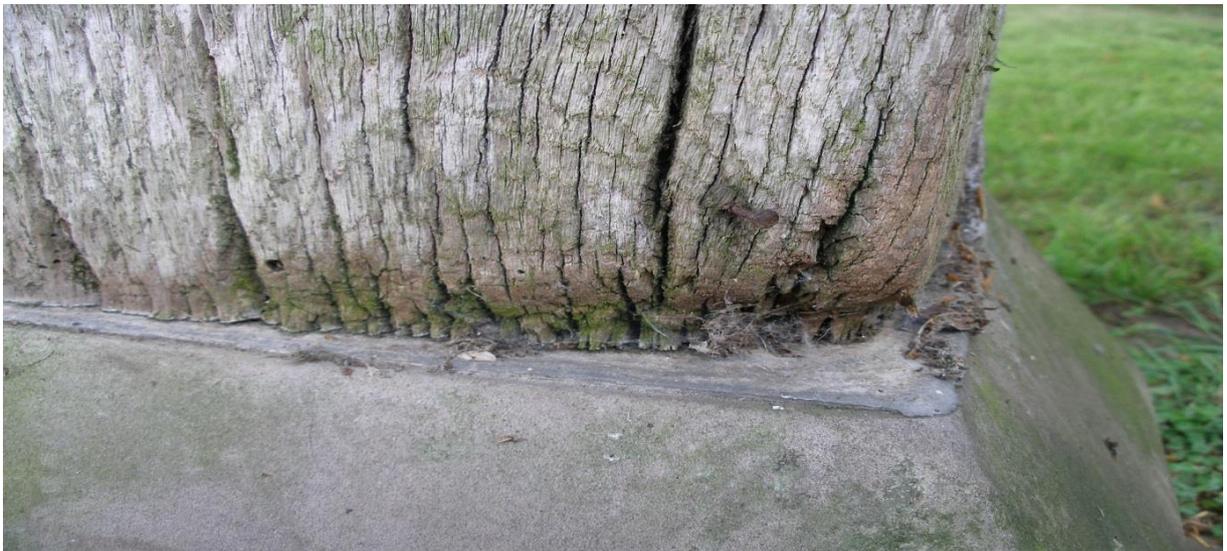
Some of the base timbers in the north gate are shown below.
