Please find outlined below the results from the ground VTA (Visual Tree Assessment) for the Giant Sequoia / Redwood adjacent to your property, and its potential relationship with any further building or landscape development at your property.

Tree Report: VTA Survey Implemented: 06/02/2019

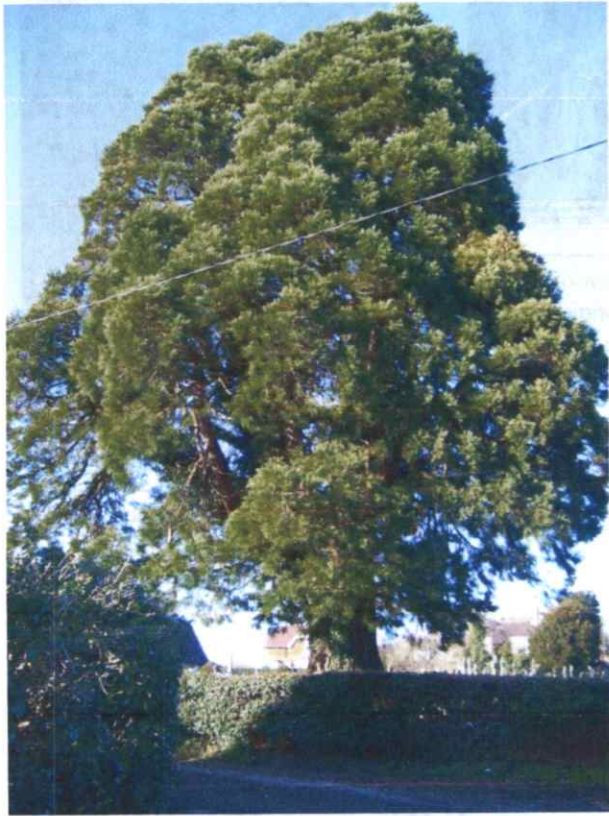
Ref. Appendix A: Photo 1 View of Giant Sequoia from the corner of 46 Laines Farm Cottages.

- The tree is well established specimen and is at full maturity with strongly developed buttresses and main stem. The size of which indicate that the tree was a lot taller in height prior to the crown reduction or leader stem breakage occurrence.

It is therefore likely that this tree has been crown reduced due to its relationship with adjacent properties; although this would need to be confirmed via a climbing survey and or church records.

Photo 1 View of Giant Sequoia from the east corner of 46 Laines Farm Cottages showing reduced height

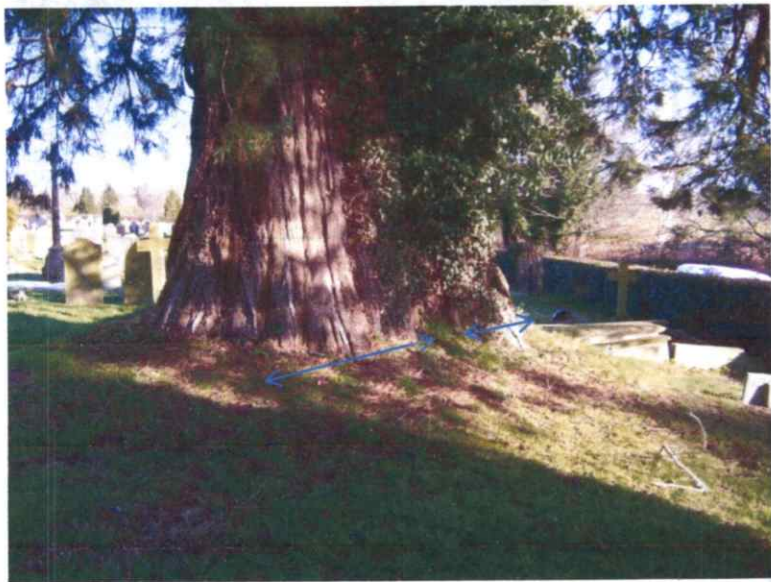
The buttresses are strongly splayed and the North to South diameter of the main stem is approx. 1m longer than the East to West buttress development which is approx. 2m in diameter. The North to South buttress development also comprises two distinct sections in the stem / buttress development. The 3m approx. diameter is divided into a 2m section and a 1m section.

The highly developed buttresses and undulating ground around the base of the tree indicate strong anchor root development in relation to a much larger / taller tree. There is no obvious VTA evidence on the edge of the boundary hedge / 30cm (1ft) approx. drop, of anchor roots having been present and cut back. This suggests the anchor routes are largely contained within the church grounds.

Photo 2 View of Giant Sequoia buttresses - North to South aspect. 2m approx. diameter and 1m approx. diameter sections Also showing the raised height of the land and the anchor root mound / undulating ground

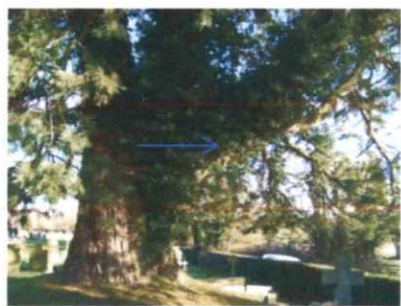
The two main lower branches, that are situated on the south side / track side of the tree measure approx. 0.75m - 1m in diameter and there is significant dead wood and ivy in the tree.

Photo 3 West view of two lower branches covered in ivy

- The tree is a mature specimen that is in need of some maintenance tree surgery to preserve it for as long as possible. The part of the tree that will need more active management and monitoring is in the higher crown area. However the two larger lower branches arising from the lower mid zone of the main stem will require botanical works at some point to ensure structural integrity. These botanical tree surgery works will ensure that such an important tree is well maintained in accordance with botanical arboricultural standards and landscape designations. This will also ensure that the structural integrity of the tree is expertly maintained and that any further growth in the tree does not affect the light of adjacent properties.

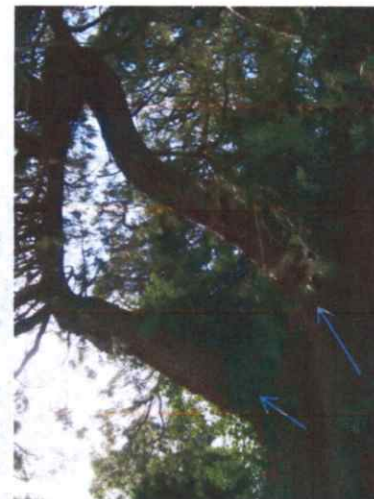
Photo 5 East view of the two lower branches originating from the main stem

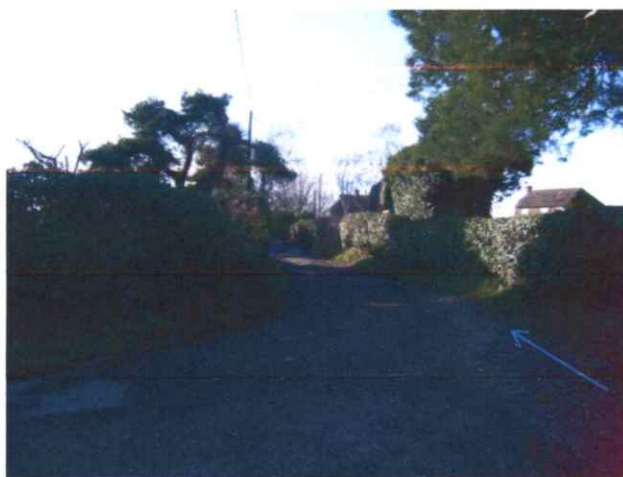
The adjacent vehicle access track is a lot lower than the level of the graveyard and could be regarded as a slightly sunken lane to some degree. The property garden is approximately the same level as the vehicle track. There is a drop in height of approx. 30.5cm (1ft) from the base of the church property hedgerow boundary to the edge / level of the vehicle access track.

Photo 6 a/ East to West view of the lane, hedge boundary and 30.5 cm approx. drop in the ground level to the track

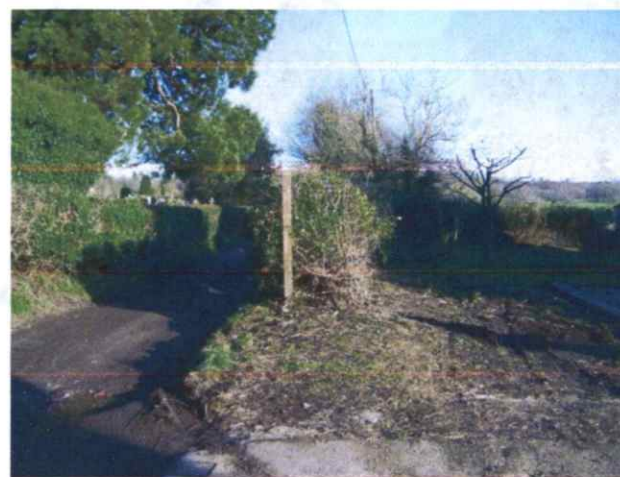
Photo 6 b/ West to East view of the lane, hedge boundary, drop in the ground level to the track and the level and gradient of the property garden

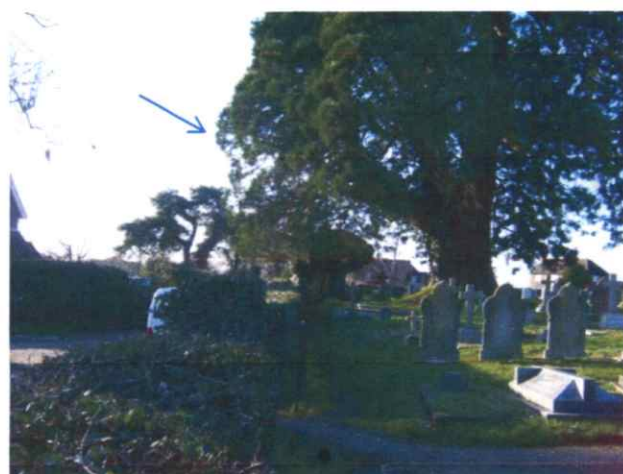
The tree foliage partially overhangs the graveyard boundary hedgerow which is approx. 1m width and the main stem buttress base edge is situated approx. 4m from the inside line of the hedge.

- The canopy drip line is encompassed within estimations for the RPA. In this instance the Giant Sequoia foliage slightly overhangs the hedge boundary and vehicle access track. However given the bank and raised topographic landscape structure in which the tree resides, the main canopy drip line is within church grounds and its related RPA.

Photo 7 East to West view of the lane, 1m wide approx. hedge boundary and partially overhanging foliage
