## **Item 7.b - Specialist 1**

Address: CUCKFIELD PARISH COUNCIL, THE QUEENS HALL, HIGH STREET, CUCKFIELD, RH17 5EL

Date / Time of Survey: 7<sup>th</sup> October 2019 @ 11:30

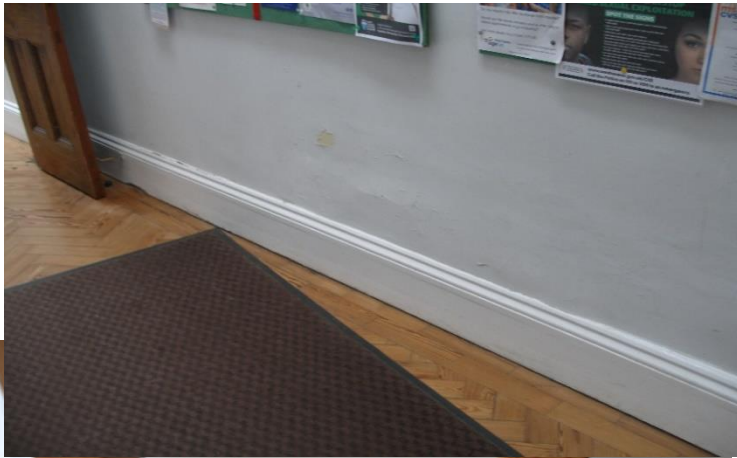
The external ground levels are very high in places along the right-hand flank (North facing wall). This means that part of the flank wall is effectively, partially below ground.

The gutters to the front part of the right-hand flank wall appear to be defective. There is water staining in various places to the external wall around the gutters here.

**High moisture meter readings** were recorded to the base of the right-hand flank wall (front section), from the utility cupboard up to the double doors. The plaster and skirting board are degraded in this area.

Front section, North facing wall.

Ensure that the gutters along the right-hand flank wall are defect free.

Damp proof the two sections of wall on the North facing flank, plus above the wall panelling and up to the surface mounted cables on the front elevation wall in the porch.

This will involve carefully removing the skirting boards on the North wall and either setting aside for re-fixing if they are sound or replacing on a like for like basis if they are badly degraded.

We will then hack off the damp degraded plaster work, taking back to the masonry.

We will then apply a specialist moisture and salt resistant membrane to the exposed masonry using a cement, polymer adhesive.

Once this has cured, we will apply a bonding base coat to the membrane, before a final plaster skim coat to match the existing.

We will re-instate the skirting boards.

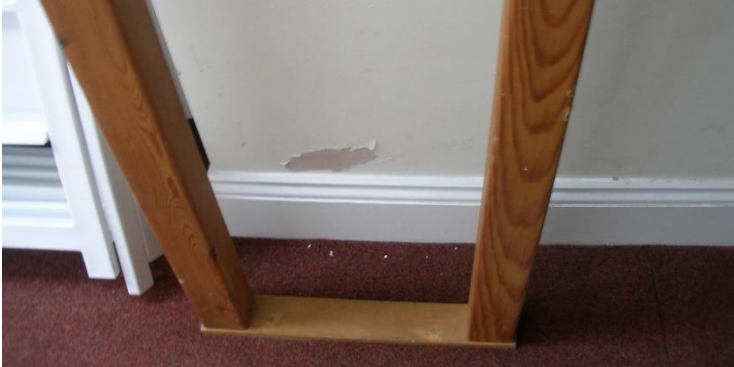
High moisture meter readings were recorded at both high- and low-level areas to the right-hand flank wall (rear section opposite the doors to the hall).

Rear section, North facing wall, opposite the doors to the hall.

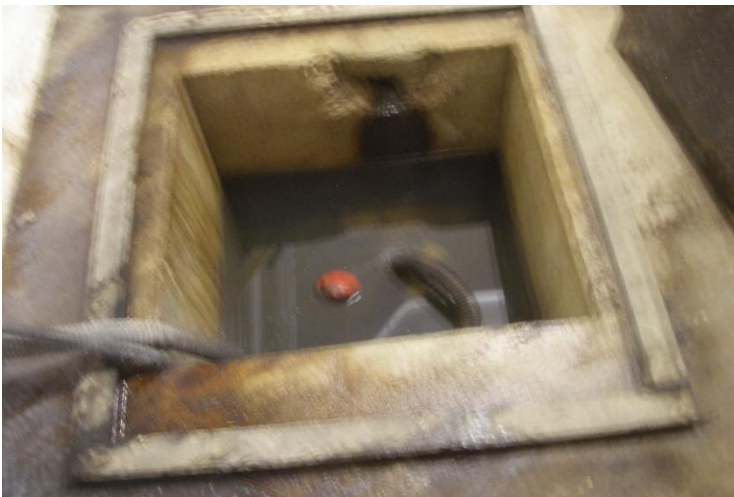
There are several gullies set into the floor of the cellar plus there is an aged sump pump set into the floor. The sump chamber was half full of water and the surface water is not draining away to the gullies very effectively. There is an ongoing plumbing leak in the plant area of the cellar.

Sump pump in the cellar floor, half full of water.

We would recommend removing and replacing the aged sump pump with a: Sentry Twin Pump– Includes two Ama-Drainer 303 pumps and a dual power alarm. Designed for use in situations where a higher level of water ingress is anticipated or where additional backup is required. Dual outlet pipes allow both pumps to operate at full capacity.

We would also recommend installing a battery back-up system.

The UPS 3000 Battery Back-Up System is an on-line double-conversion Uninterruptible Power Supply (UPS) offering the highest levels of resilience and protection. This provides power to one of the submersible pumps in case of a loss of mains power allowing for continued pump operation.

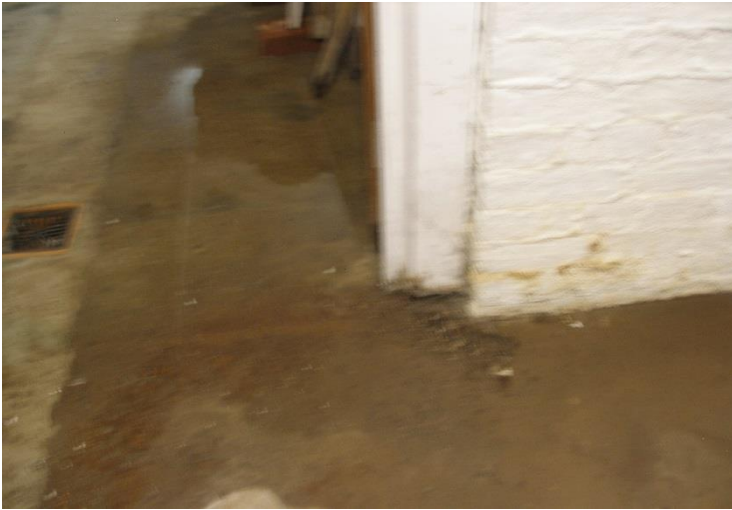
There is surface water to parts of the cellar floor. The cellar walls are damp in places. The cellar is and always will be damp unless it has been waterproofed in order to provide a dry habitable environment. In its current state it is only suitable for the storage of non-perishable items. I have not quoted for waterproofing the cellar in this report.

Surface water and gully in the cellar.

You should also consider improving the drainage on the cellar floor to ensure that free water is taken away to the existing gullies and sump pump, rather than just pooling on the cellar floor.

To improve the drainage we would recommend cutting into the existing concrete slab and installing Aquadrain drainage channels around as many of the perimeter cellar walls as is possible (there is a stud wall and some plant equipment that may limit this) and across the floor as necessary, to either the existing gullies or to the sump pump. The channel would be set into the floor to improve the drainage in the cellar. See example of the drainage channel below.

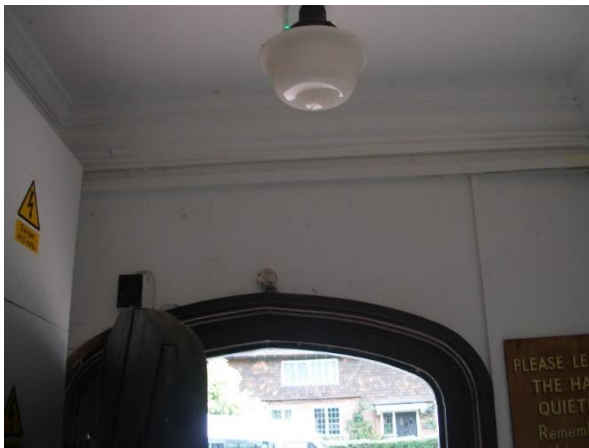
High readings were recorded above the front door in the porch area.

Damp around the front door in the porch area.
