LANDBUILD

Cuckfield Operation Watershed Existing Layout

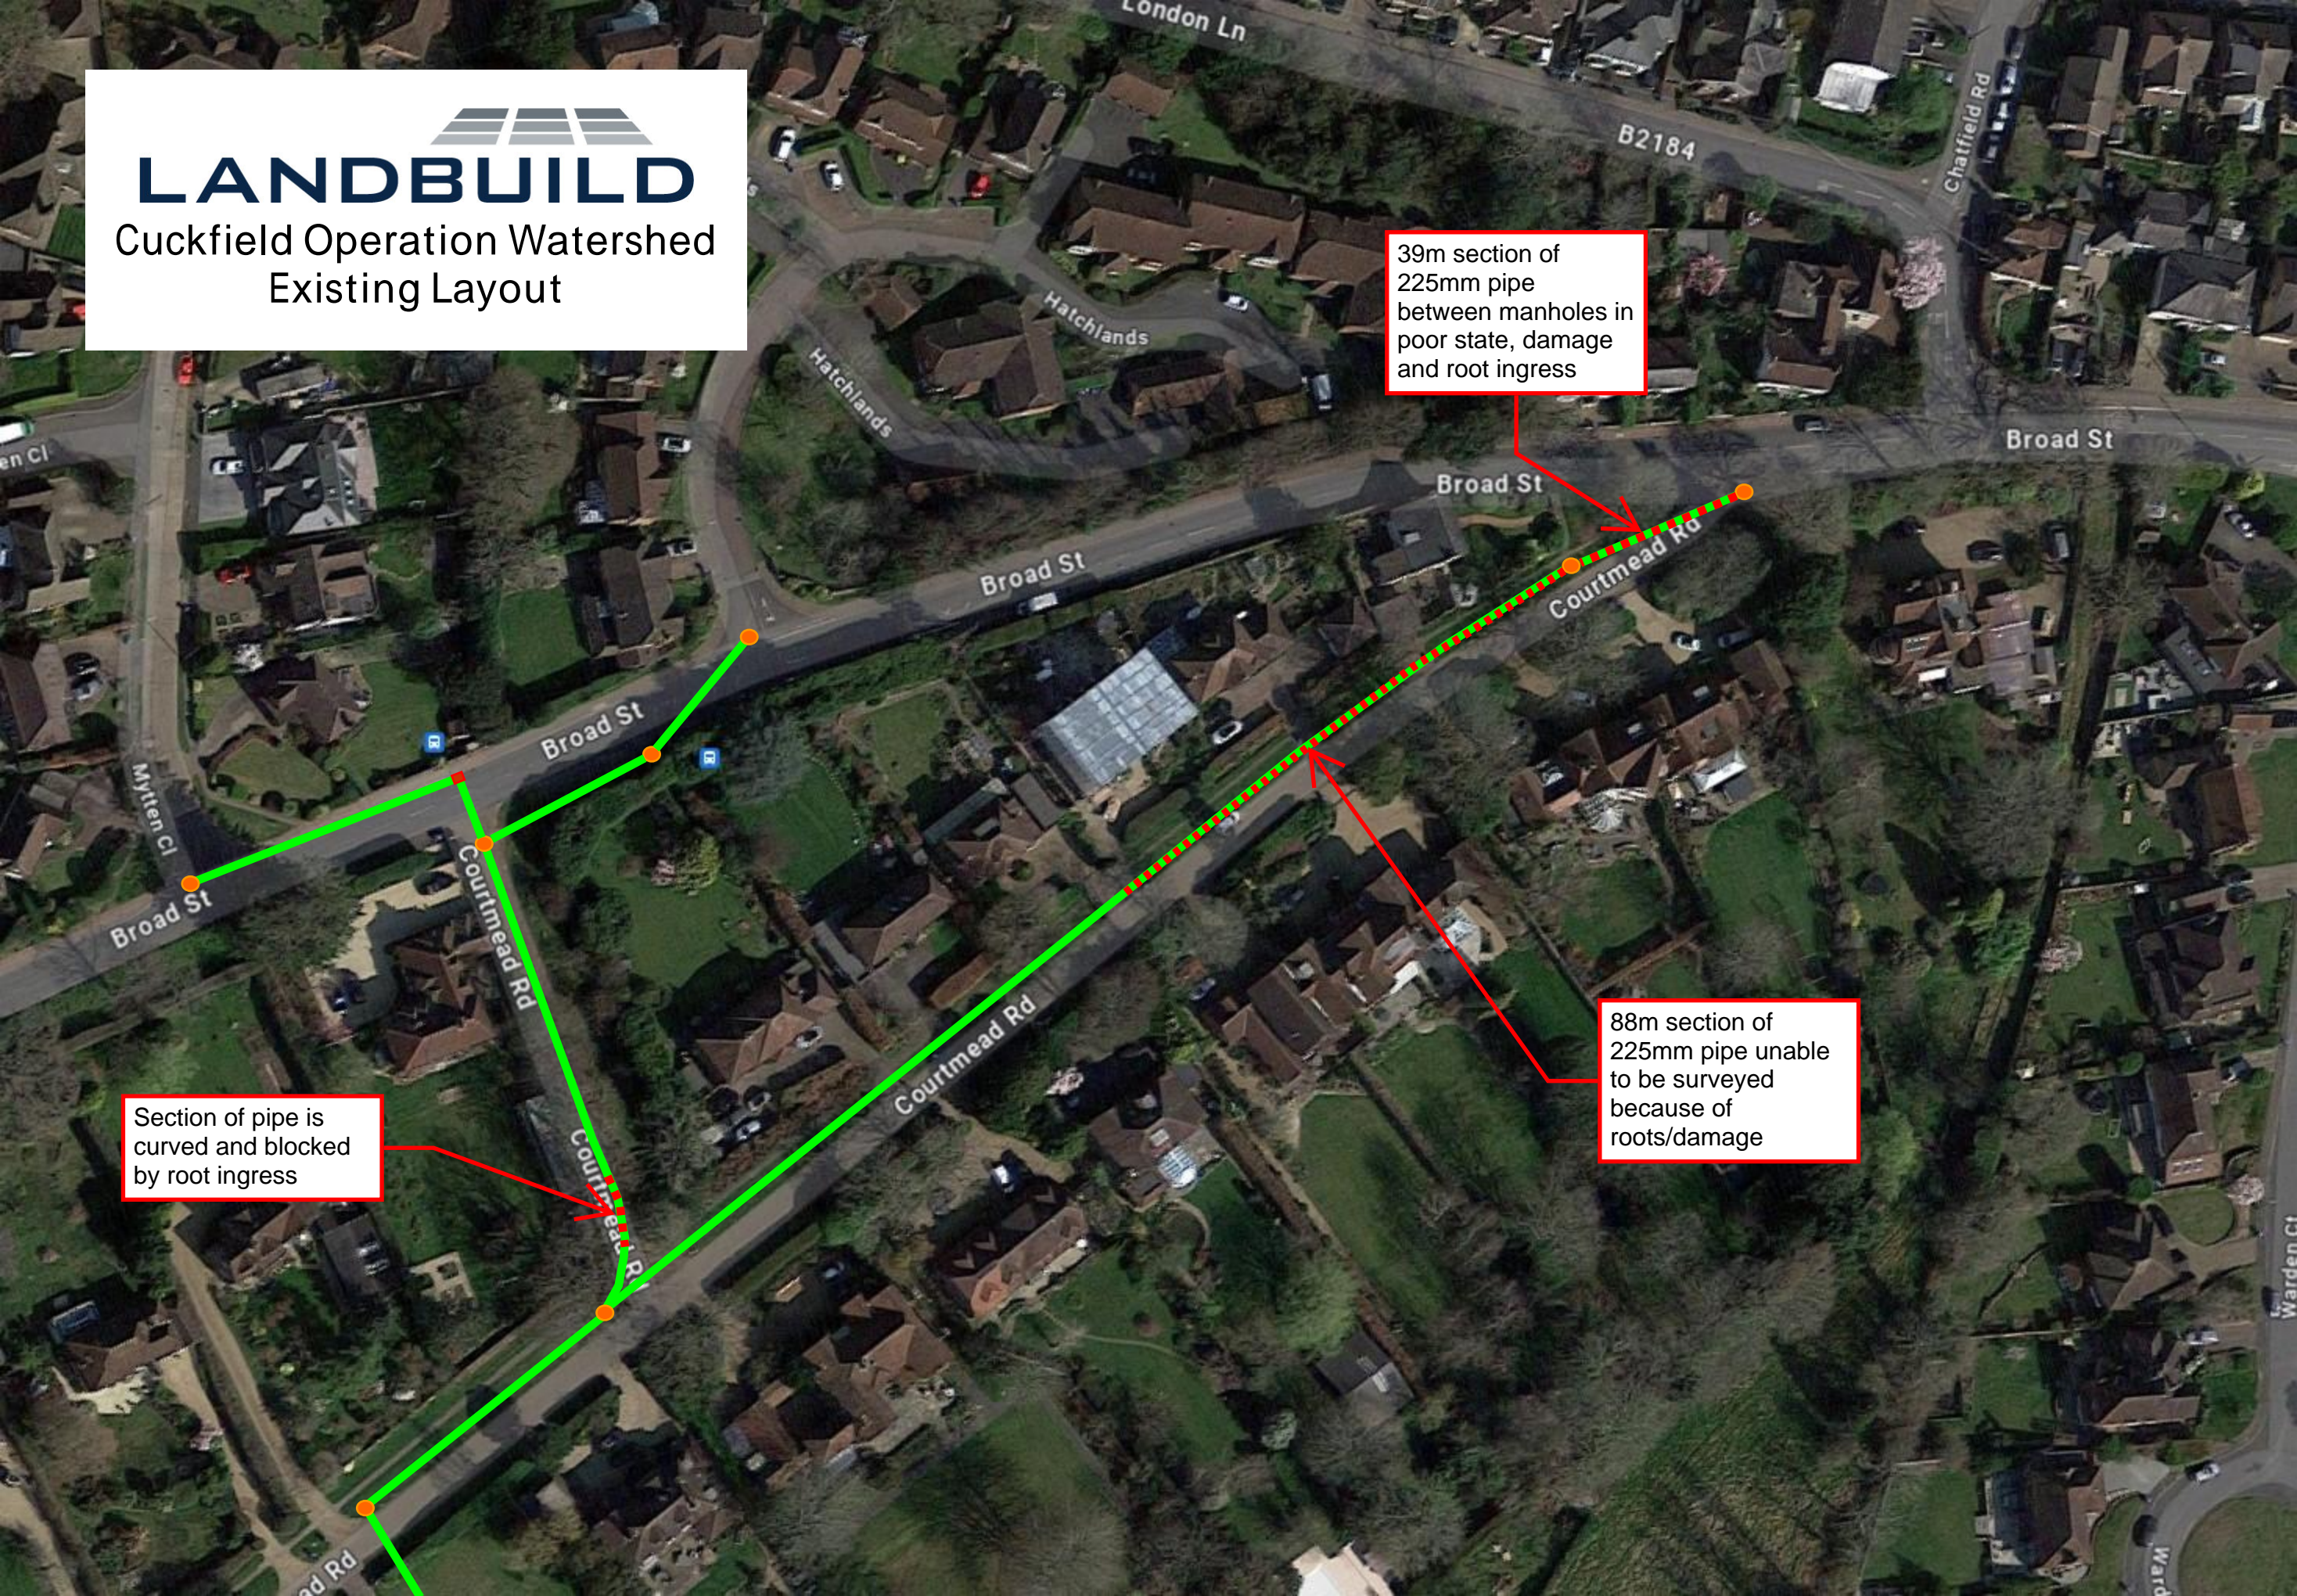
39m section of 225mm pipe between manholes in poor state, damage and root ingress

88m section of 225mm pipe unable to be surveyed because of roots/damage

Section of pipe is curved and blocked by root ingress
