Safety Inspection Report

Annual Inspection

Whitemans Green Skate Park

19 July 2024

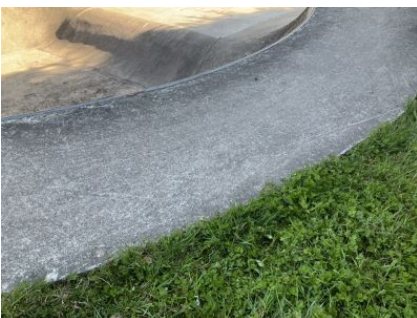
General Surface - Grass

Trip points on the surface.

Build up surface level to remove trip points.

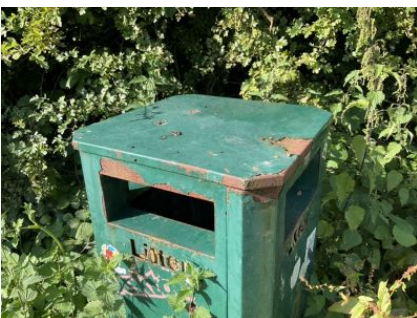
Litter Bins

Paintwork is in poor condition.

De-scale back to good base material and coat with lead free paint, using appropriate precautions. Repairs may be necessary where corrosion is severe.

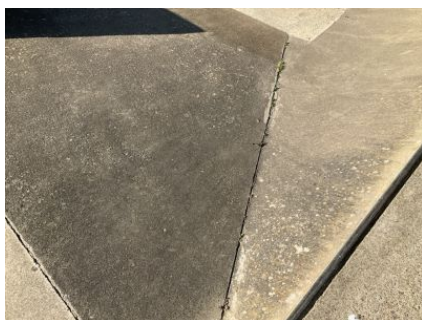
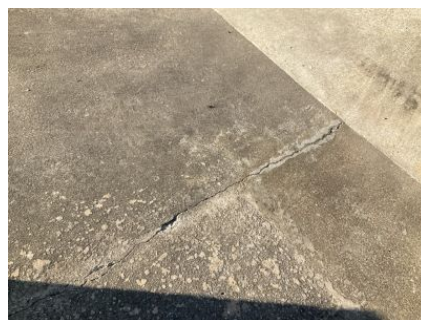
Skate - Bowl

Concrete edges are in poor condition.

Edges and joints are damaged. Repair.

8

Repair.

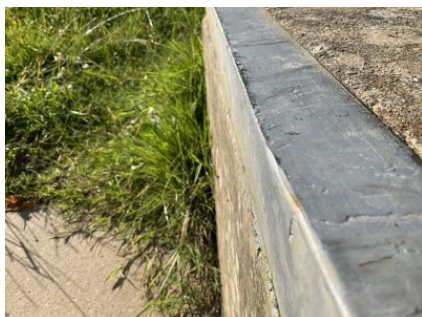
Skate - Box - Straight Kerb

The item is not compliant with the requirements of the relevant standards. The surfacing meets with the requirements of the relevant standards.

Edges not radiused or chamfered.

8

No reasonably practicable action is identified.

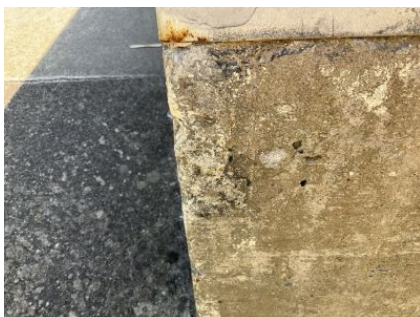
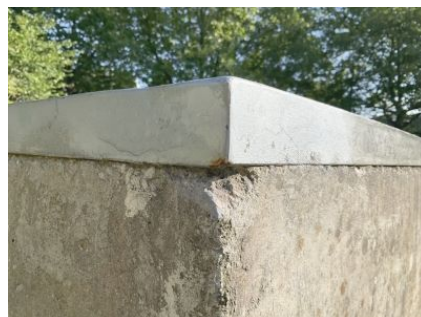
Skate - Grind Box (Centre)

Concrete edges are in poor condition.

8

Repair.

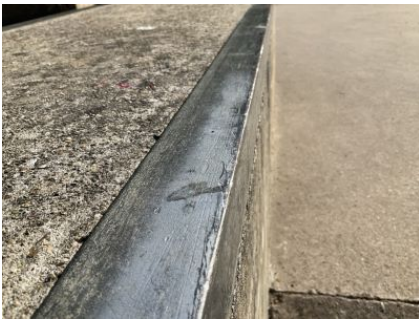
The item is not compliant with the requirements of the relevant standards. The surfacing meets with the requirements of the relevant standards.

Edges not radiused or chamfered.

8

No reasonably practicable action is identified.

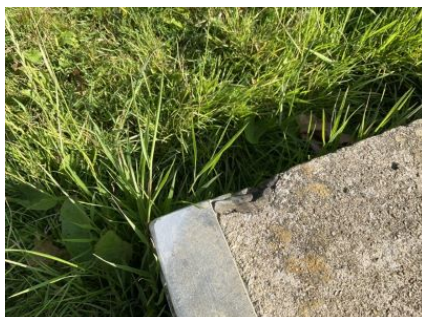
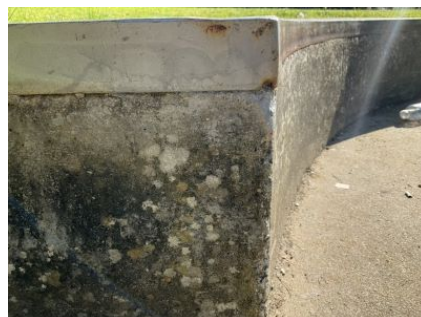
Skate - Grind Box - Corner

Concrete edges are in poor condition.

7

Repair.

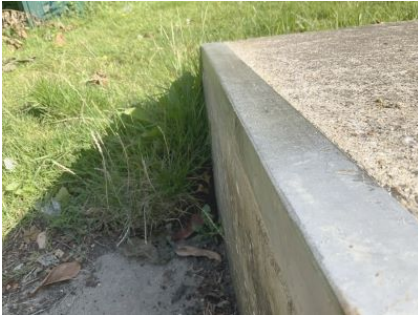
The item is not compliant with the requirements of the relevant standards. The surfacing meets with the requirements of the relevant standards.

Edges not radiused or chamfered.

8

No reasonably practicable action is identified.
