# Safety Inspection Report

## Horsefield Green Development

Cuckfield Parish Council

19 July 2024

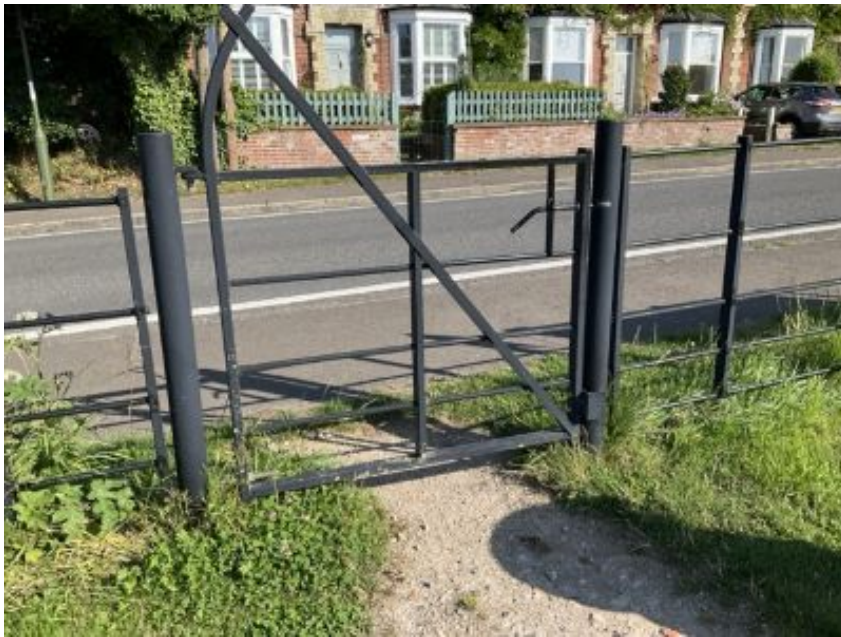
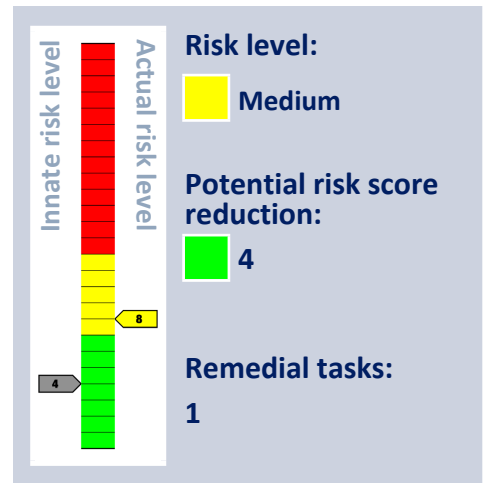
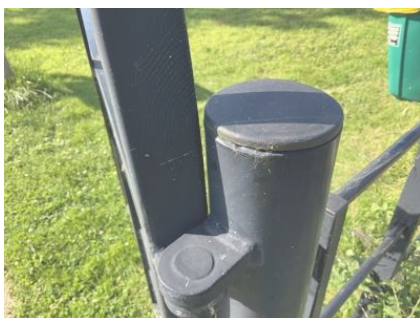
# Gate

There is a crushing or shearing point on the side of the gate. Where the gaps reduce to less than 12 mm these have been known to cause serious, permanent injury to children, especially on the hinge side where the leverage forces are significant.

At hanging post when fully open. Consider fitting stop bar to lower frame.

Medium

8

Read the notes for further action.

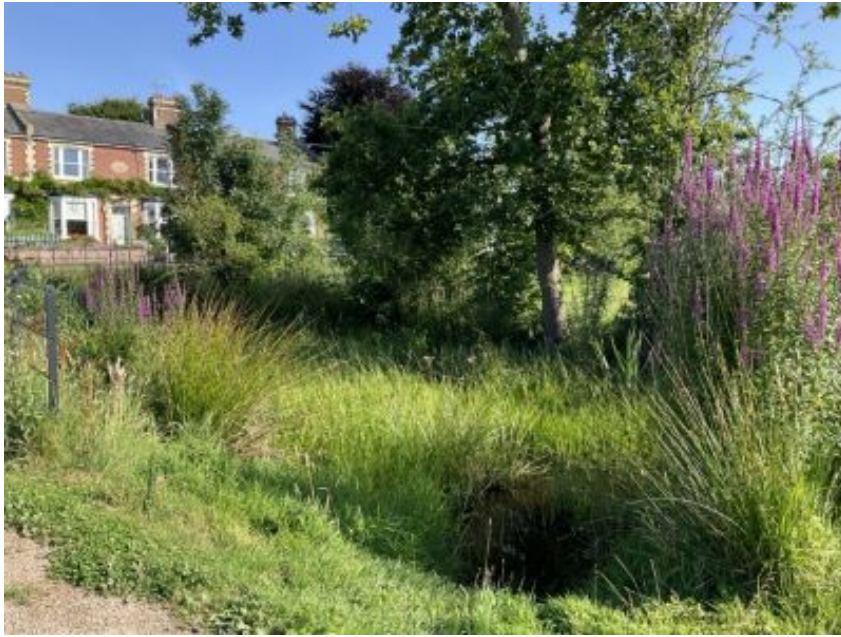
# Pond

Additional comments are noted below.

Water naturally attracts children. Recommend fencing.

Medium

Read the notes for further action.

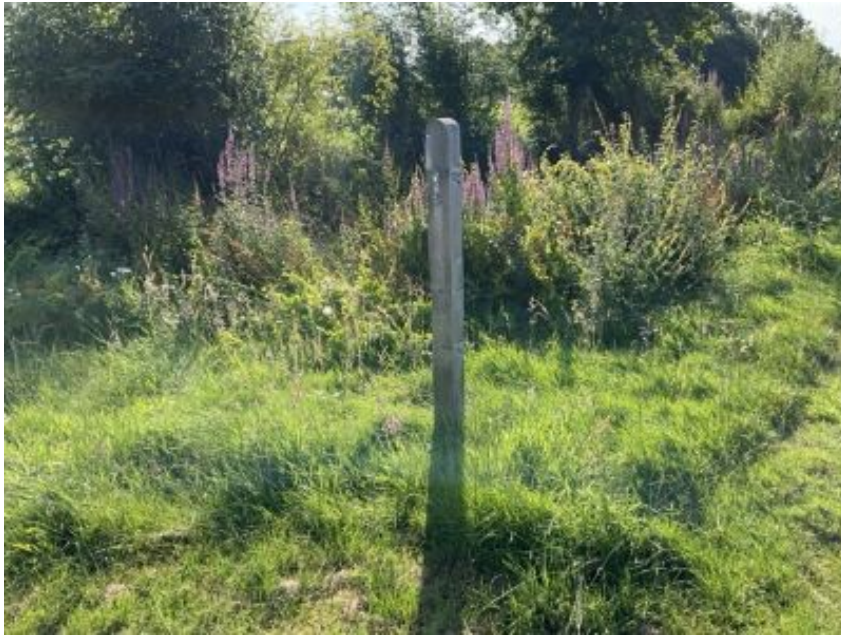
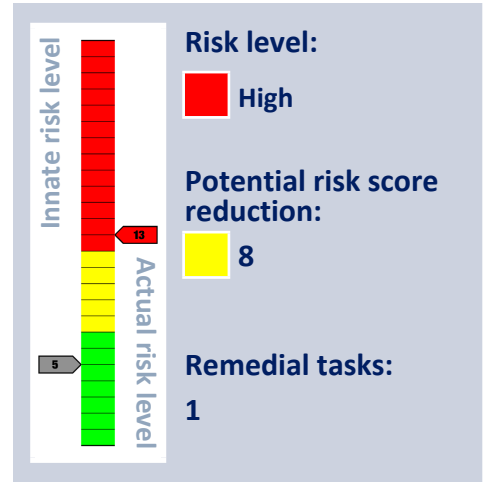
# Water Safety - Life Ring

Missing item.

Life saver ring is missing.

High

13

Replace.
