Safety Inspection Report

Annual Inspection

Horsefield Green Development

Cuckfield Parish Council

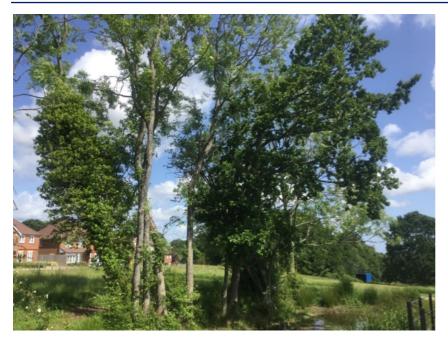
Planting

Dead branches present - qualified tree inspection recommended.

8

Medium

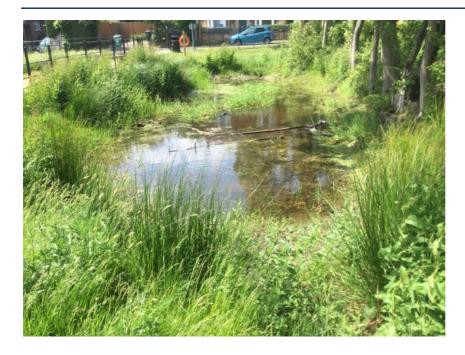
Pond

Water naturally attracts children. The pond is low at present, with muddy edges.

8

Branches and log in pond, these may encourage access by children - it is recommended that they are removed.
